## WV CREATE CENTER PRELIMINARY ENGINEERING REPORT Bluefield, West Virginia

Prepared for the  
Bluefield WV Economic Development Authority

T&L Project No. 18027  
June 26, 2024  
ISSUED FOR REVIEW

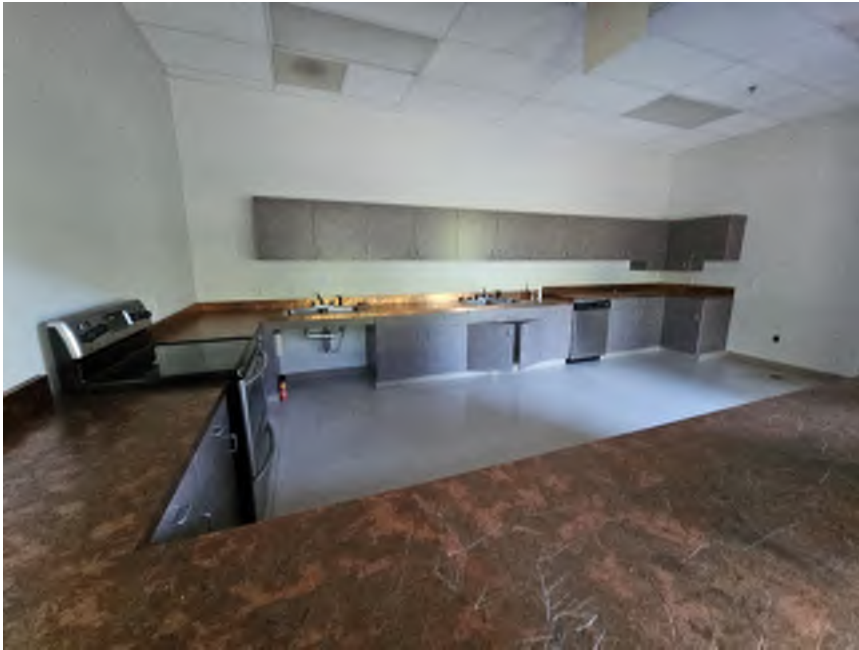
The existing kitchen, at the former café, has two sinks, a dishwasher and range. The range does not have any type of exhaust hood, which is required. There are multiple kitchenettes located throughout the building on each floor. The kitchenettes have a small under the counter refrigerator, sink, and 2 burner electric cooktop.

*Figure 1 Main Kitchen at Breakroom: No range hood, no pipe insulation under sink(*

- Exit signs be adjusted throughout the facility so that exit signs are visible from all locations in corridors.
- Remove all kitchenettes. These are not accessible, and the cooktop is hazardous (no range hood).

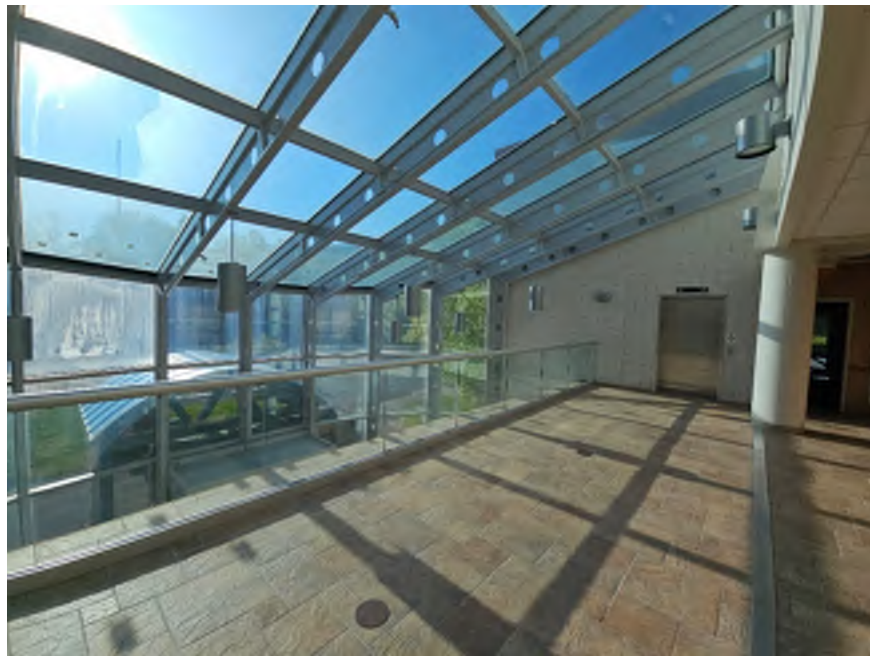
The main entrance is a curtain wall system (glass and structural system) that spans two-stories. It was noted that some of the glazing seals have been compromised and have become cloudy. The glazing at the entrance is problematic due to the eastern exposure. In the morning the entrance heat is overwhelming, and the mechanical system cannot keep the space at a desirable level. Also, shades had to be installed in front of the reception desk, since the direct sunlight into the area causes difficulty in seeing entering guests.

*Figure 2 Main Lobby curtainwall system*

- Two options are suggested for the Main Lobby:
  - Remove all glazing only and replace it with heavily tinted glazing or spandrel panels at the sloped glazing area to reduce the light and heat transmittance.

The existing roof curtain wall is expected to be replaced with spandrel glass to reduce heat load and glare in the lobby. If a structural roof is proposed for the lobby, the entire proprietary curtain wall and structure will be required to be replaced with roof deck, structural beams and columns; however, the existing foundations may be able to be reutilized if the new lobby is frame similarly.

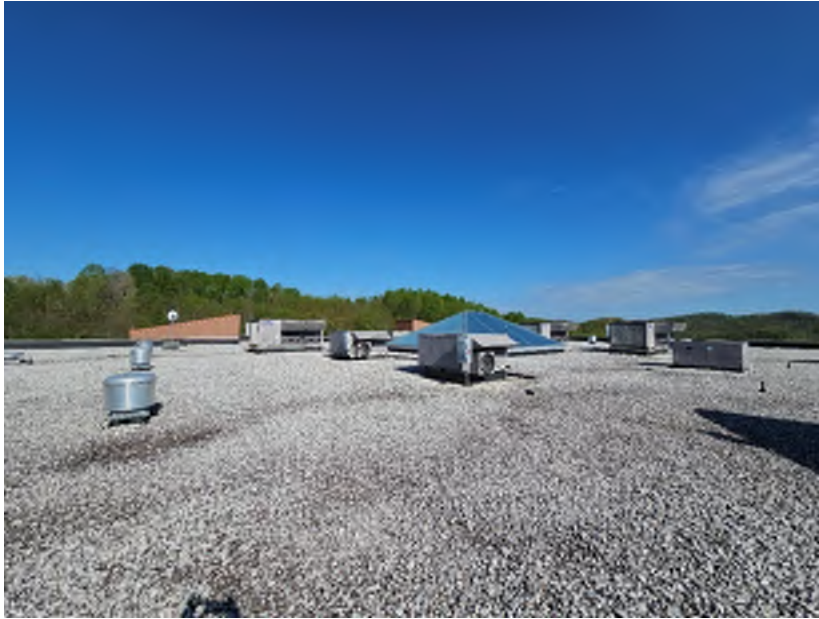
The roof is ballasted ethylene propylene diene membrane (EPDM) that is the original roofing. Since it is over 20 years old, it is nearing the end of its useful life. Only a few leaks have been reported in the building. There are (6) original rooftop units (RTU) that are nearing the end of their useful life.

*Figure 3 Ballasted Roof*

- Roof Replacement:
  - Core drill roof insulation to determine moisture content.
  - Remove ballast and EPDM membrane. If insulation is dry and meets code, install new fully adhered 90 mil (30 year warranty).

- If moisture is present in the insulation, T&L recommends removal of all the insulation to deck and install a new base course insulation (5") and tapered insulation (1/4" per ft) to the existing roof drains.
  - Provide crickets at all mechanical units for proper drainage.
- T&L has provided a layout for proposed tenant occupancies. Two tenants, CART and OMNIS have been identified on the attached floor plans. Other spaces have been proposed for future tenants. The proposed spaces were divided into areas along the main exit corridors. Future tenant spaces would need to be evaluated for space and program needs.

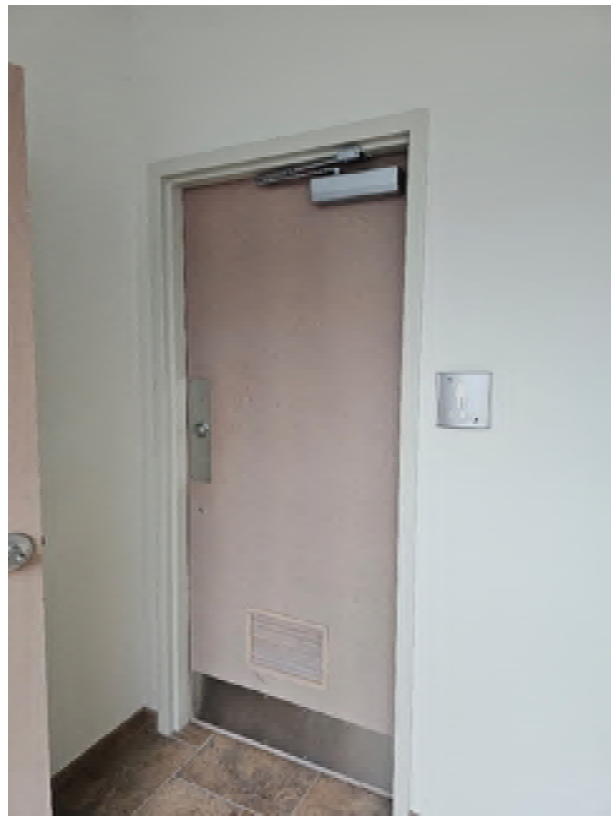
*Figure 4 Added wall encroaches on ADA clearance into restroom (4 occurrences)*

Remove the partition near the men's room on the west side of the building, which creates the storage room. As noted previously, the partition encroaches on the door clearance for entrance into the men's room. See floor plan for suggested correction.

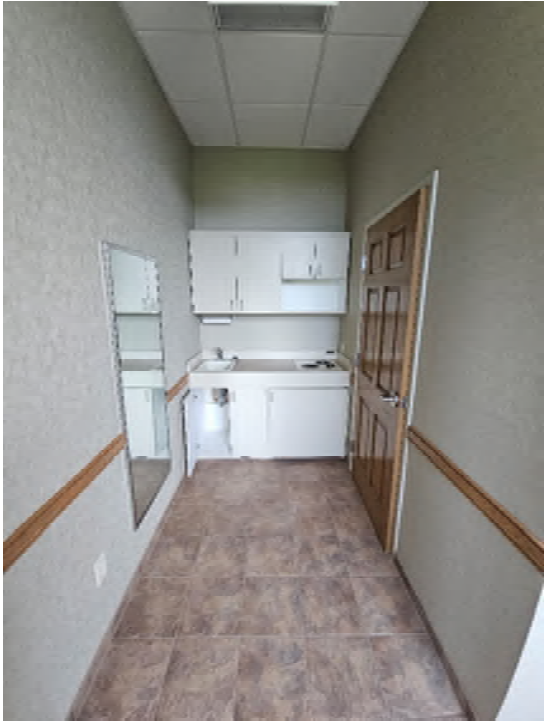
*Figure 5* Kitchennettes are not accessible and no hood over burners.

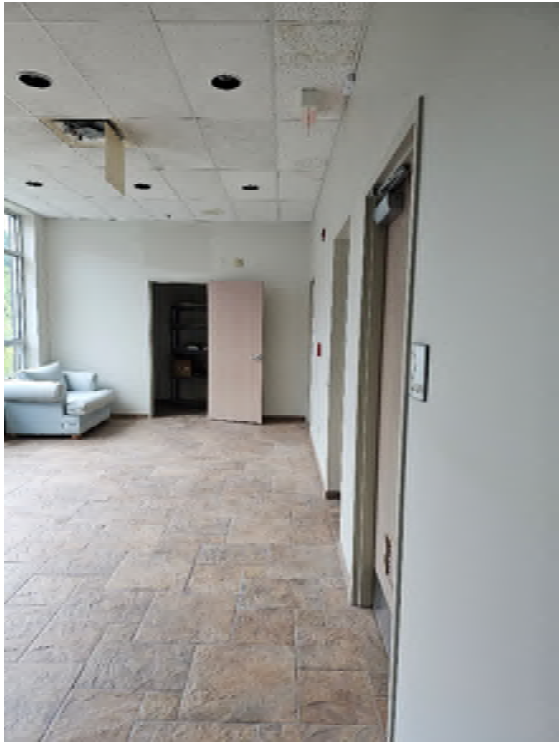
The building has four stair towers at the four corners of the building that meet current code. Some of the exit signs are located so they are not visible from a distance and are not mounted in the proper direction. There does not appear to be any dead-end corridors.

*Figure 6* Exit sign is not visible from path of travel

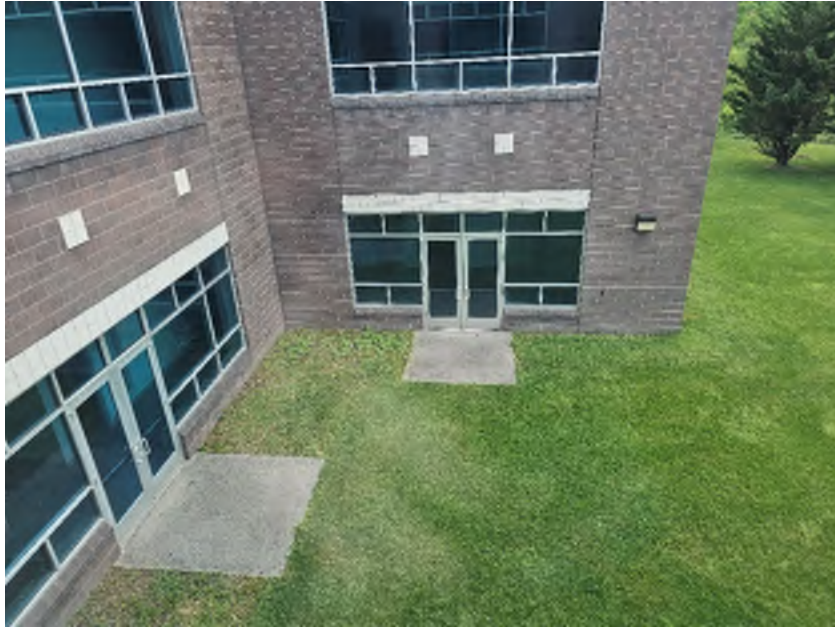
The exits at the west end of the building have a small concrete pad only and do not lead to the parking area.

*Figure 7 Sidewalks need to extend to nearest parking lot.*
