## WV CREATE CENTER PRELIMINARY ENGINEERING REPORT Bluefield, West Virginia

Prepared for the  
Bluefield WV Economic Development Authority

T&L Project No. 18027  
June 26, 2024  
ISSUED FOR REVIEW

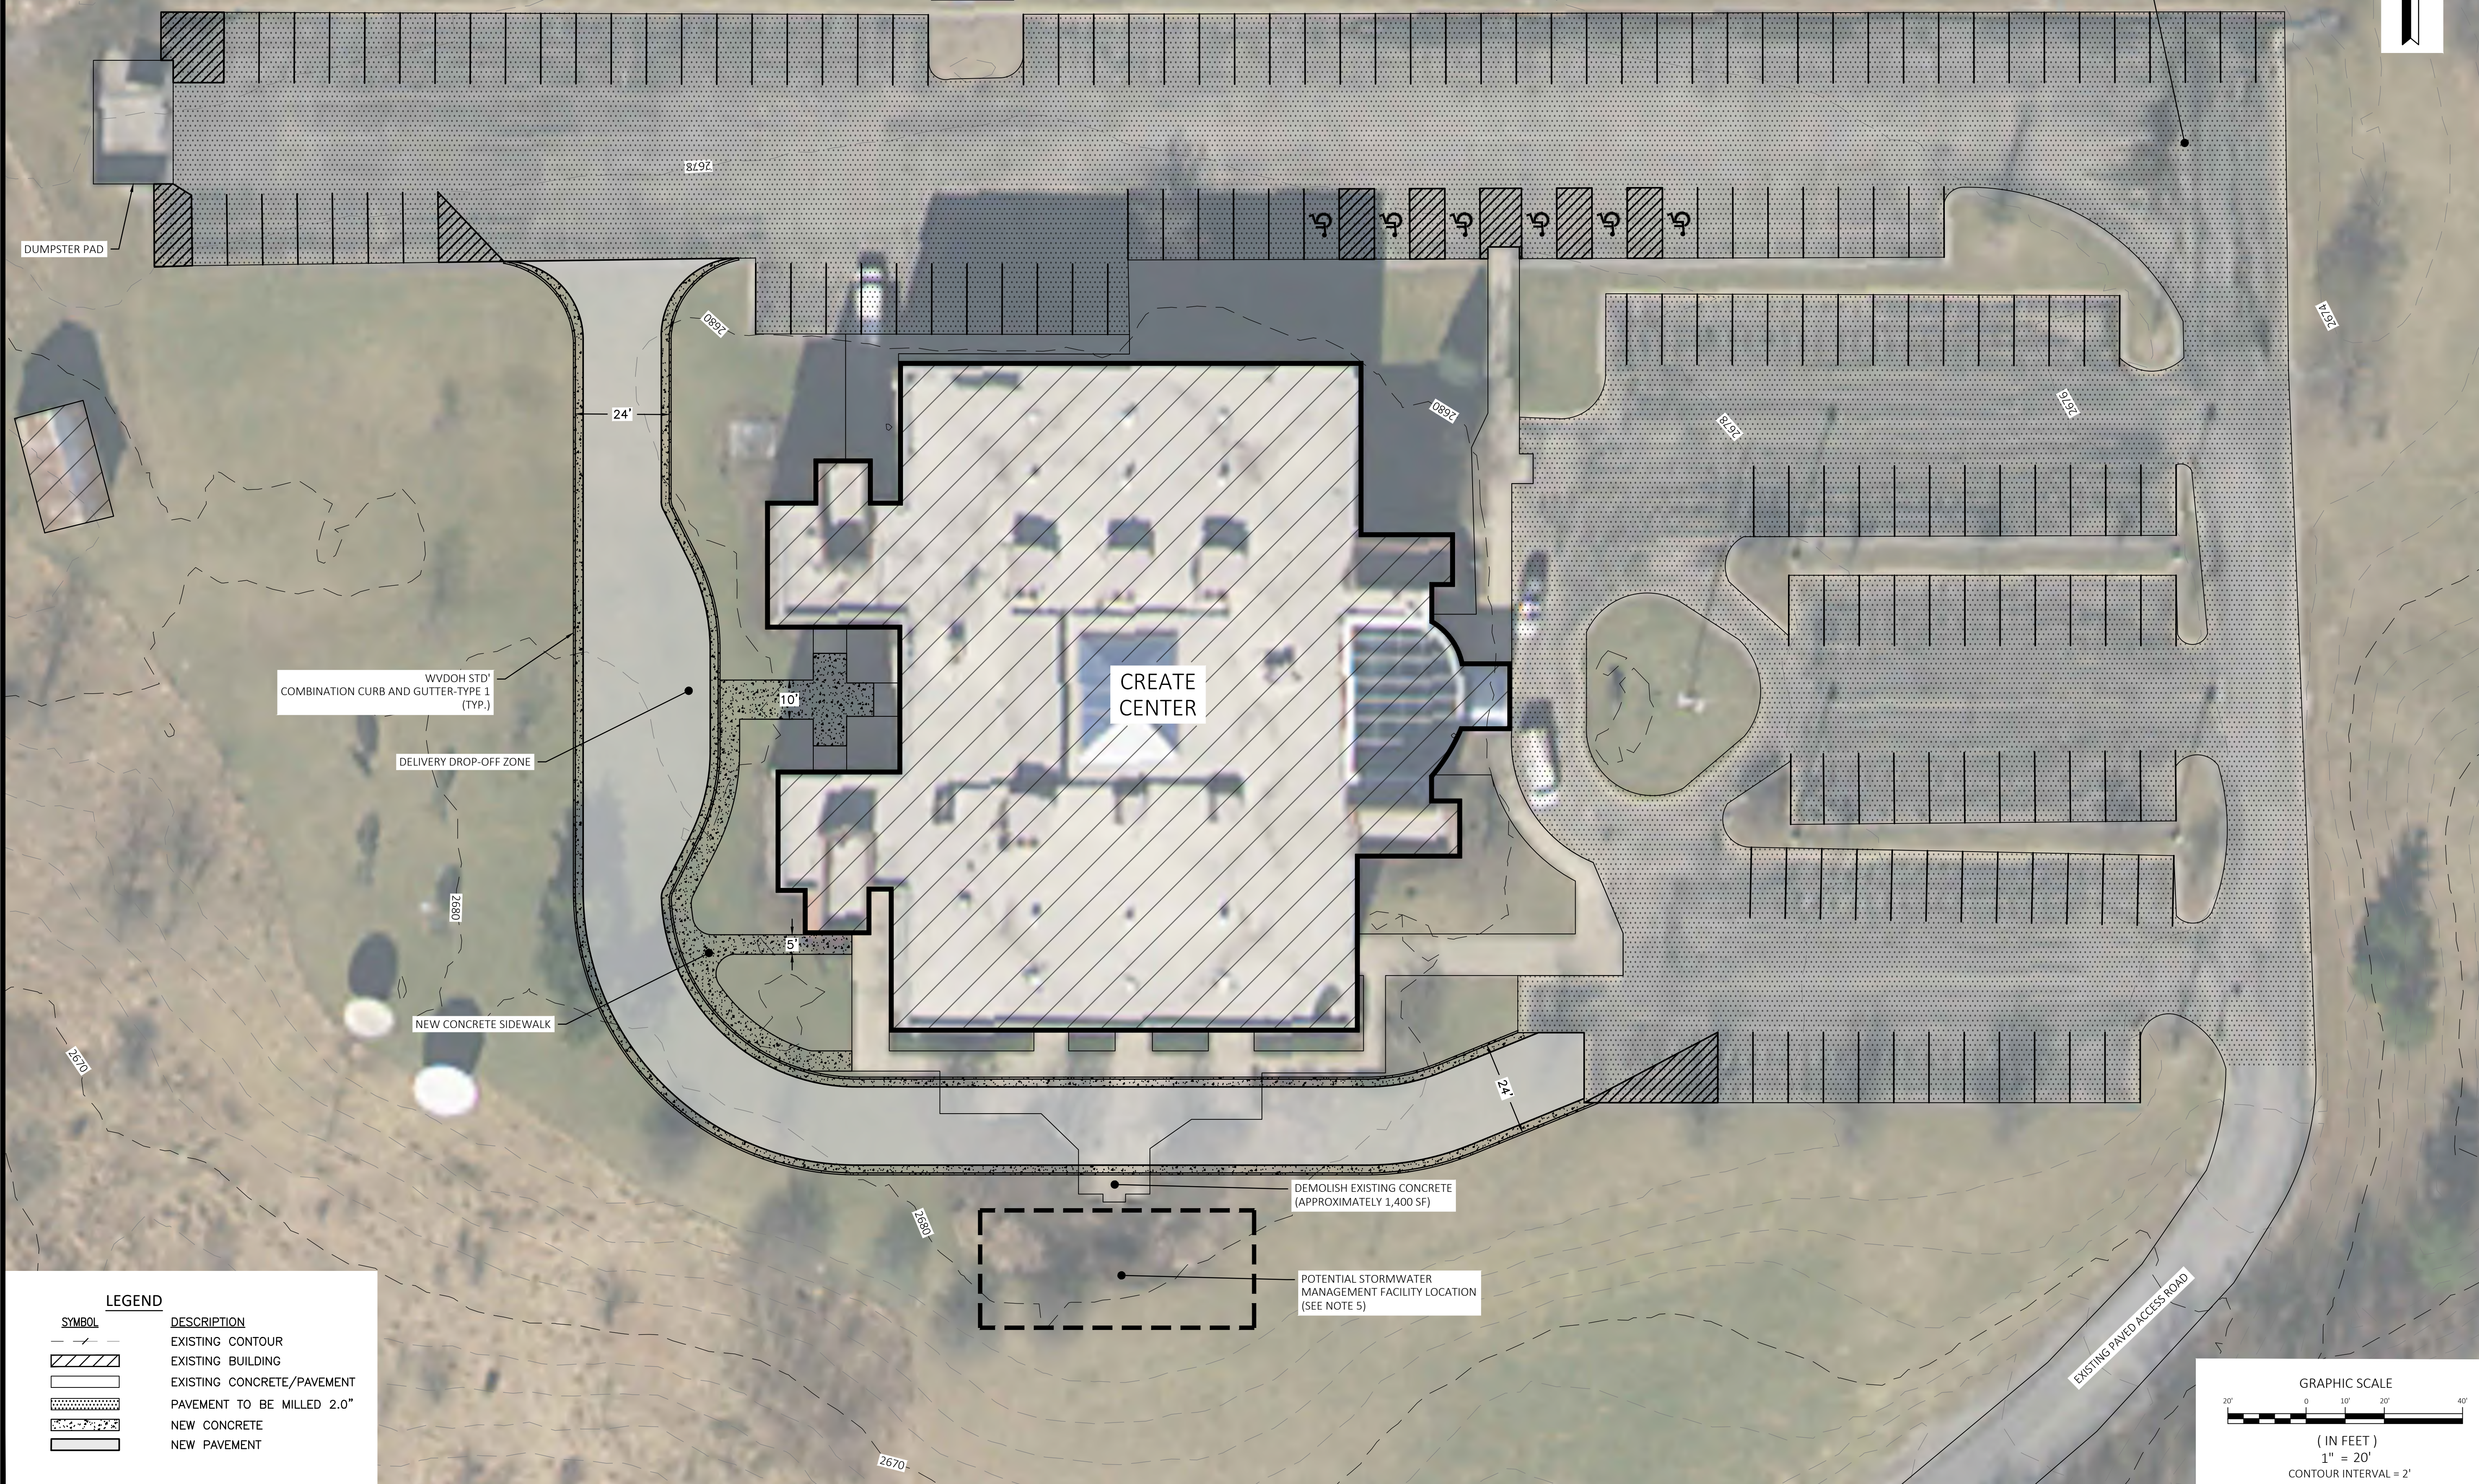
Sheet No.  
**EX-1**

The existing paved surfaces within the parking areas and interconnected drive aisles are in poor condition. Therefore, at a minimum, it is recommended to mill and overlay these areas. Consequently, the existing parking stall striping will require re-striping. The total area requiring mill and overlay is approximately 70,000 square feet and a total re-striping length of approximately 3,500 lineal feet. Six (6) ADA parking stalls have been provided toward the northeastern corner of the Create Center with an additional 156 general parking stalls in the surrounding parking areas for a total of 162 parking stalls. The Create Center does have an existing drop-off area at the main entrance. No modifications to this drop-off area are anticipated. Please see exhibit EX-1 for details.

Due to general site maneuverability, it is not recommended to provide improvements for a WB-67 to deliver goods to the Create Center. Although it may be feasible, it would require further evaluation to confirm. An access road circumventing the Create Center is achievable; however, the steeper slopes on the southern portion of the site should be avoided. Storm drain infrastructure would be easily installed and designed to handle the additional runoff generated by the proposed impervious areas. Earthwork will be required to construct the proposed improvements with minimal amounts of cut and fill. A grading plan will be required to quantify the earthwork required. If excess cut should be generated, the material could be stockpiled on the western perimeter of the site and fully stabilized. A geotechnical investigation to determine the status of the potential covered-subsidence sinkhole would be necessary but permitting discharges into the feature would likely not pose a great challenge as post development discharges would be managed via onsite detention. The current condition of the asphalt paving is poor throughout the parking areas and drive aisles. Therefore, milling and overlaying is recommended with associated parking stall re-striping.

6. TOTAL RE-STRIPING LENGTH FOR ALL PARKING STALL STRIPING IS APPROXIMATELY 3,500 LINEAL FEET. 156 GENERAL PARKING STALLS AND 6 ADA PARKING STALLS ARE ILLUSTRATED FOR A COMBINED PARKING STALL COUNT OF 162.

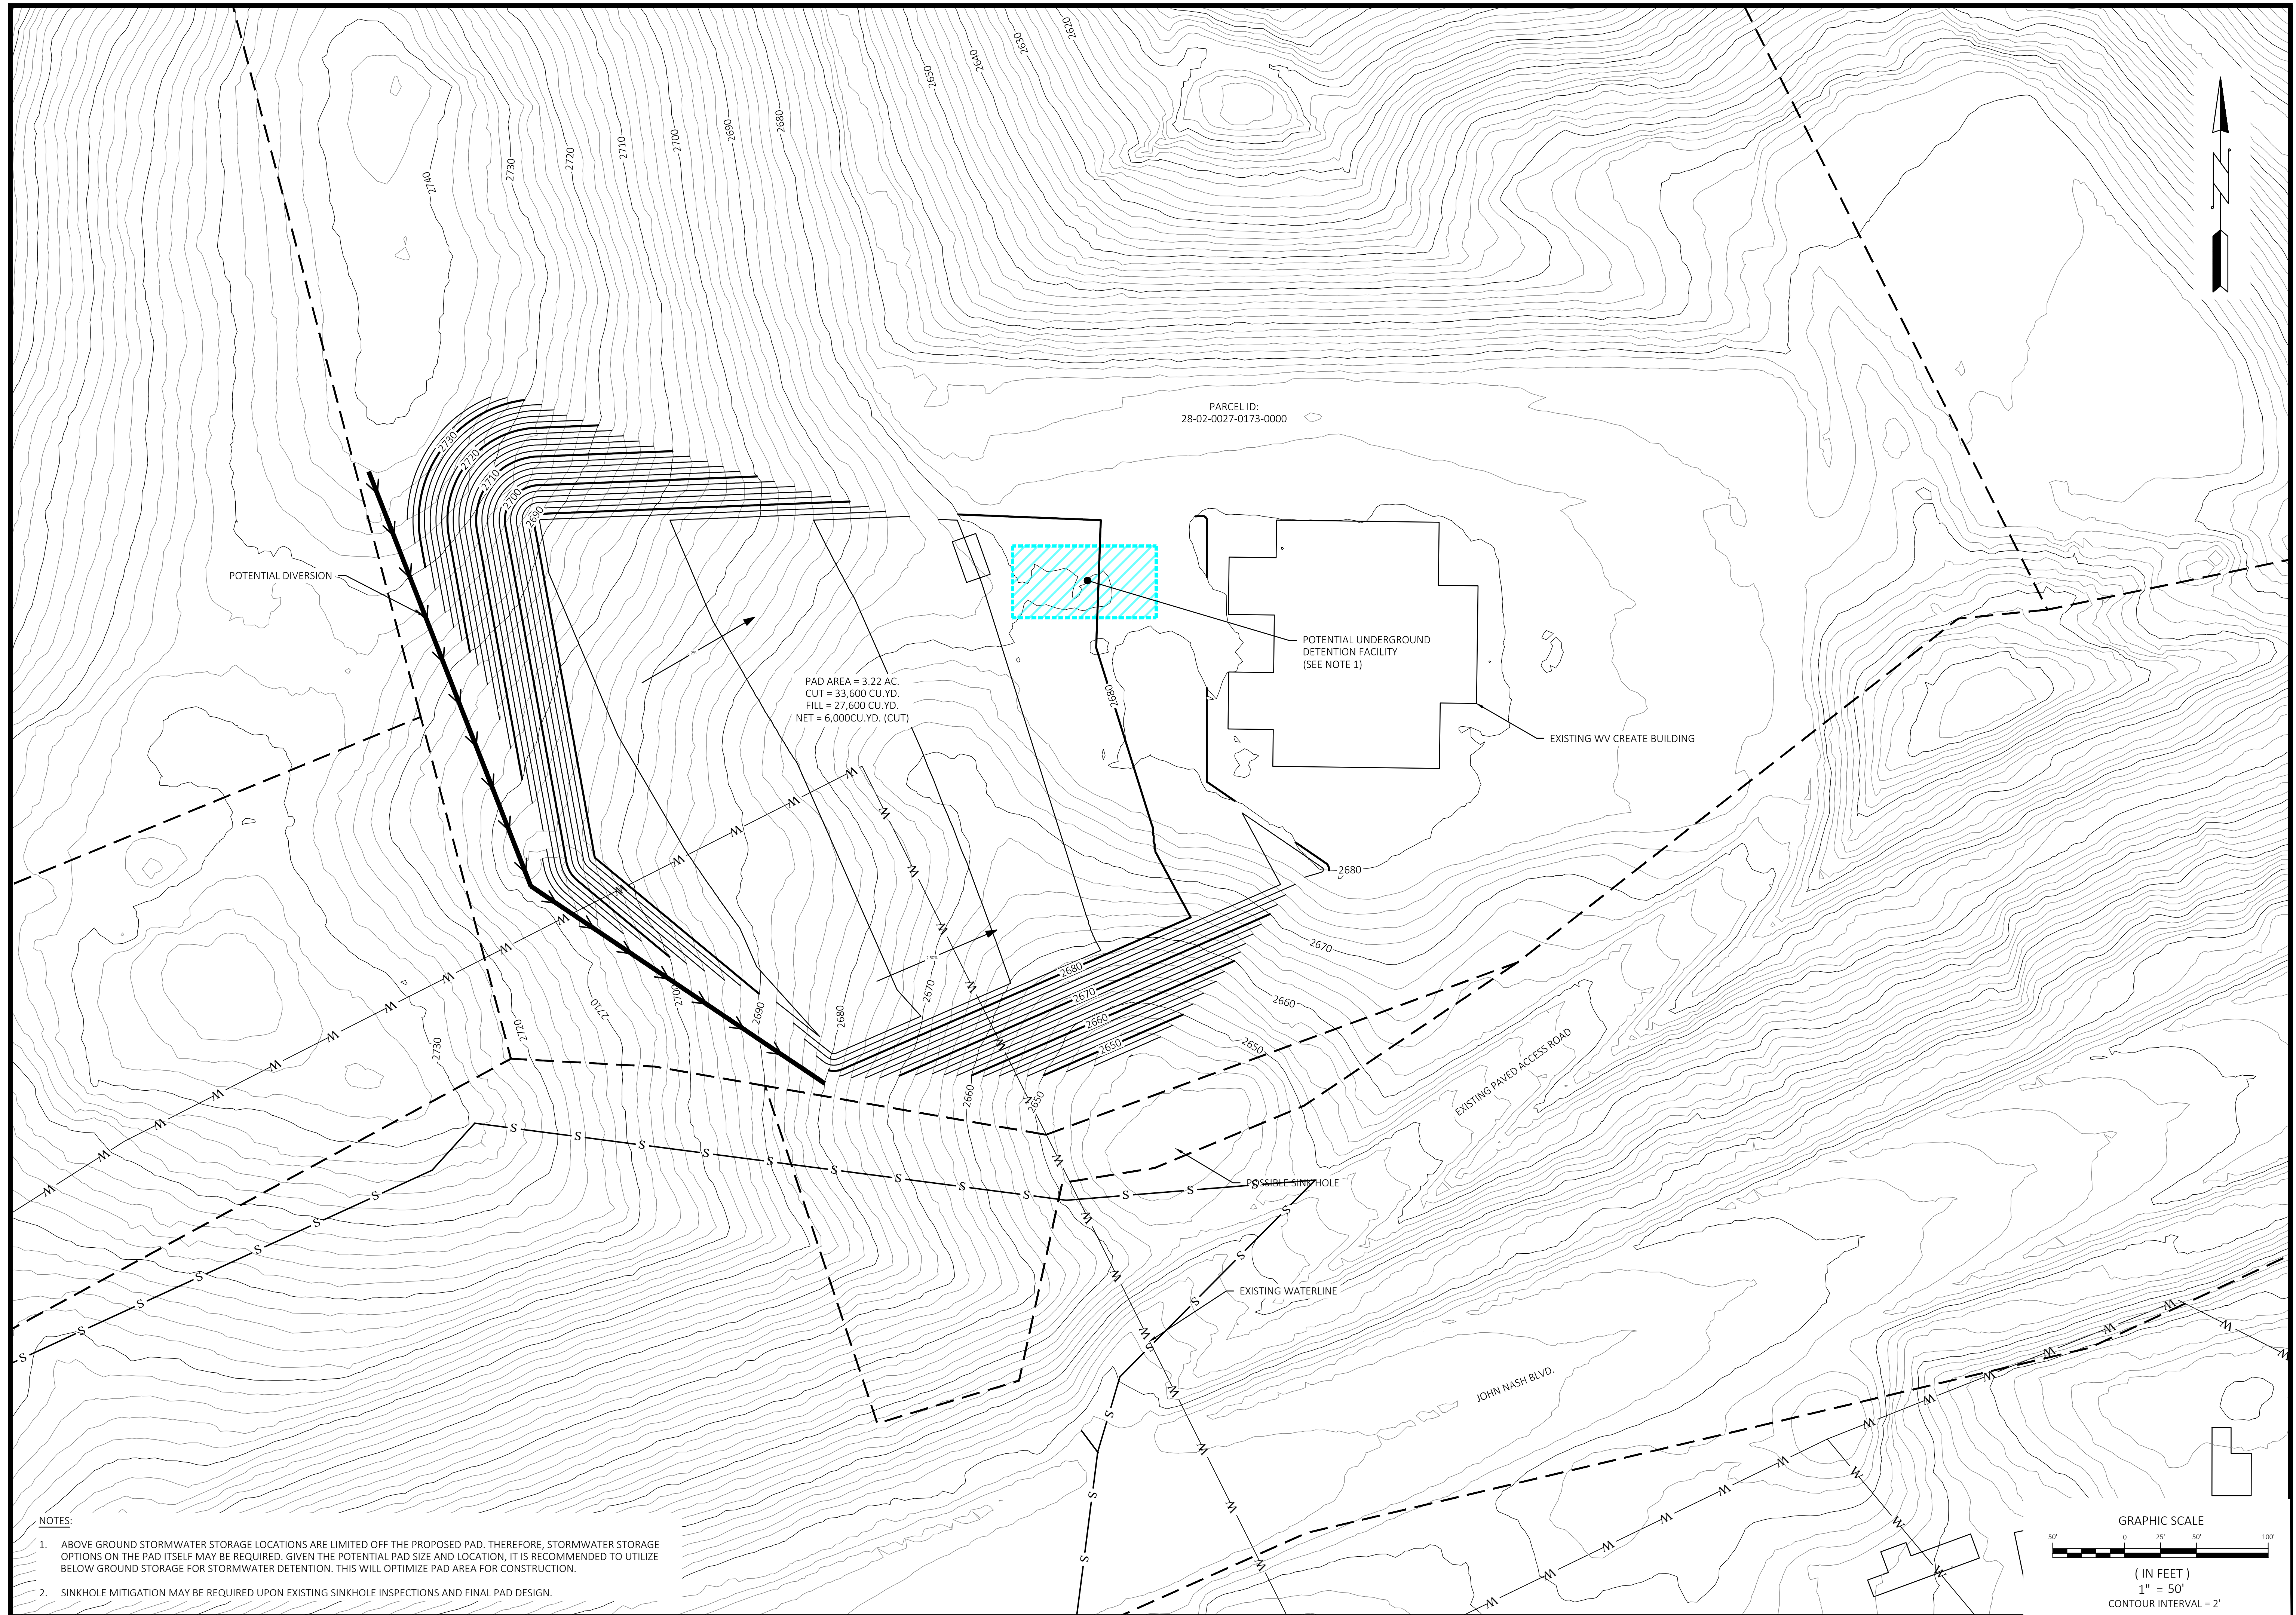
Sheet No.  
**EX-4**

- NOTES:
1. ABOVE GROUND STORMWATER STORAGE LOCATIONS ARE LIMITED OFF THE PROPOSED PAD. THEREFORE, STORMWATER STORAGE OPTIONS ON THE PAD ITSELF MAY BE REQUIRED. GIVEN THE POTENTIAL PAD SIZE AND LOCATION, IT IS RECOMMENDED TO UTILIZE BELOW GROUND STORAGE FOR STORMWATER DETENTION. THIS WILL OPTIMIZE PAD AREA FOR CONSTRUCTION.
  2. SINKHOLE MITIGATION MAY BE REQUIRED UPON EXISTING SINKHOLE INSPECTIONS AND FINAL PAD DESIGN.

- One (1) sinkhole is possibly located on or adjacent to this site and near John Nash Blvd.
- The northern portions of the property, as well as the adjacent properties are not suitable for grading activities due to the steep mountainous terrain.
